**DEPARTMENT OF TRANSPORTATION****DIVISION OF ENGINEERING SERVICES**

Contract #: 04-0120F4Cty: SF/ALA Rte: 80 PM: 13.2/13.9File #: 69.28**WELDING INSPECTION REPORT****Resident Engineer:**Pursell, Gary**Address:** 333 Burma Road**City:** Oakland, CA 94607**Report No:** WIR-002975**Date Inspected:** 10-Jun-2008**Project Name:** SAS Superstructure**OSM Arrival Time:** 700**Prime Contractor:** American Bridge/Fluor Enterprises, a JV**OSM Departure Time:** 1700**Contractor:** Zhenhua Port Machinery Company, Ltd (ZPMC), Changxing Island **Location:** Shanghai, China**CWI Name:** Sun Wei**CWI Present:** Yes No**Inspected CWI report:** Yes No N/A**Rod Oven in Use:** Yes No N/A**Electrode to specification:** Yes No N/A**Weld Procedures Followed:** Yes No N/A**Qualified Welders:** Yes No N/A**Verified Joint Fit-up:** Yes No N/A**Approved Drawings:** Yes No N/A**Approved WPS:** Yes No N/A**Delayed / Cancelled:** Yes No N/A**Bridge No:** 34-0006**Component:** OBG and Tower**Summary of Items Observed:**

**Production Monitoring Test Macro-Etch Samples**

**77M Partial Tower Mock-ups**

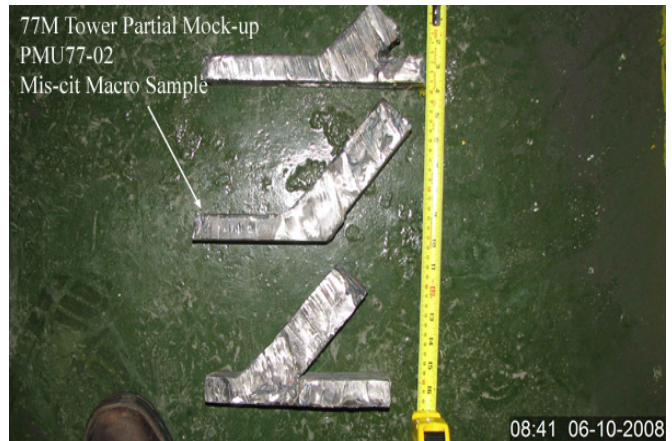
## Diagonal Stiffener to Skin Plate WT-32

ABF Representative Mike Williams informed the Quality Assurance Inspector that a portion of the skin plate was accidentally cut off. A digital photograph below illustrates the discrepancy. After some discussion between the Quality Assurance Inspector and Mr. Williams, it was decided to select another macro sample.
